# **INVESTIGATION OF WATER LEAKAGE MECHANISM IN THE KARSTIC DAM SITE, SAMANALAWEWA, SRI LANKA**

A Dissertation submitted in partial fulfilment of  
the requirements for the  
Degree of Doctor of Philosophy

Department of Engineering Systems and Technology  
Graduate School of Science and Engineering  
Saga University  
Saga, Japan

**September 2007**

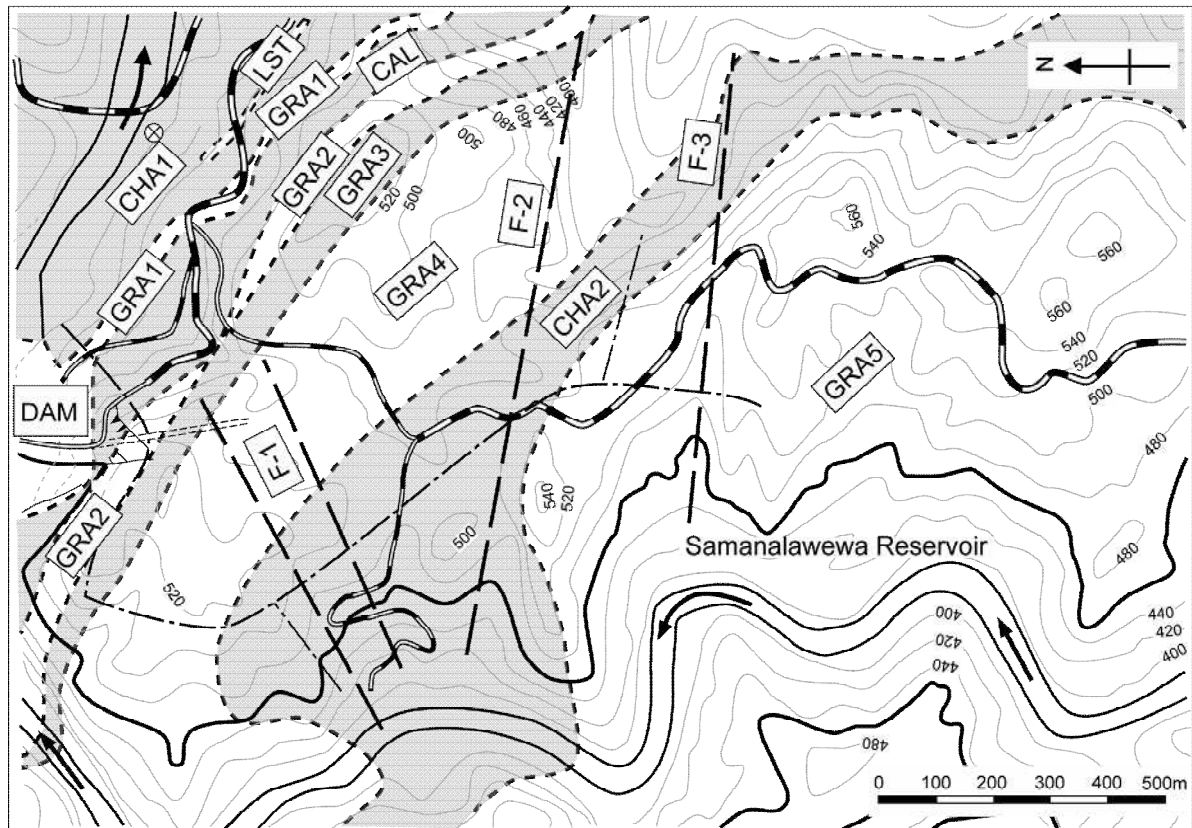
**Figure 3.2** Site geological map

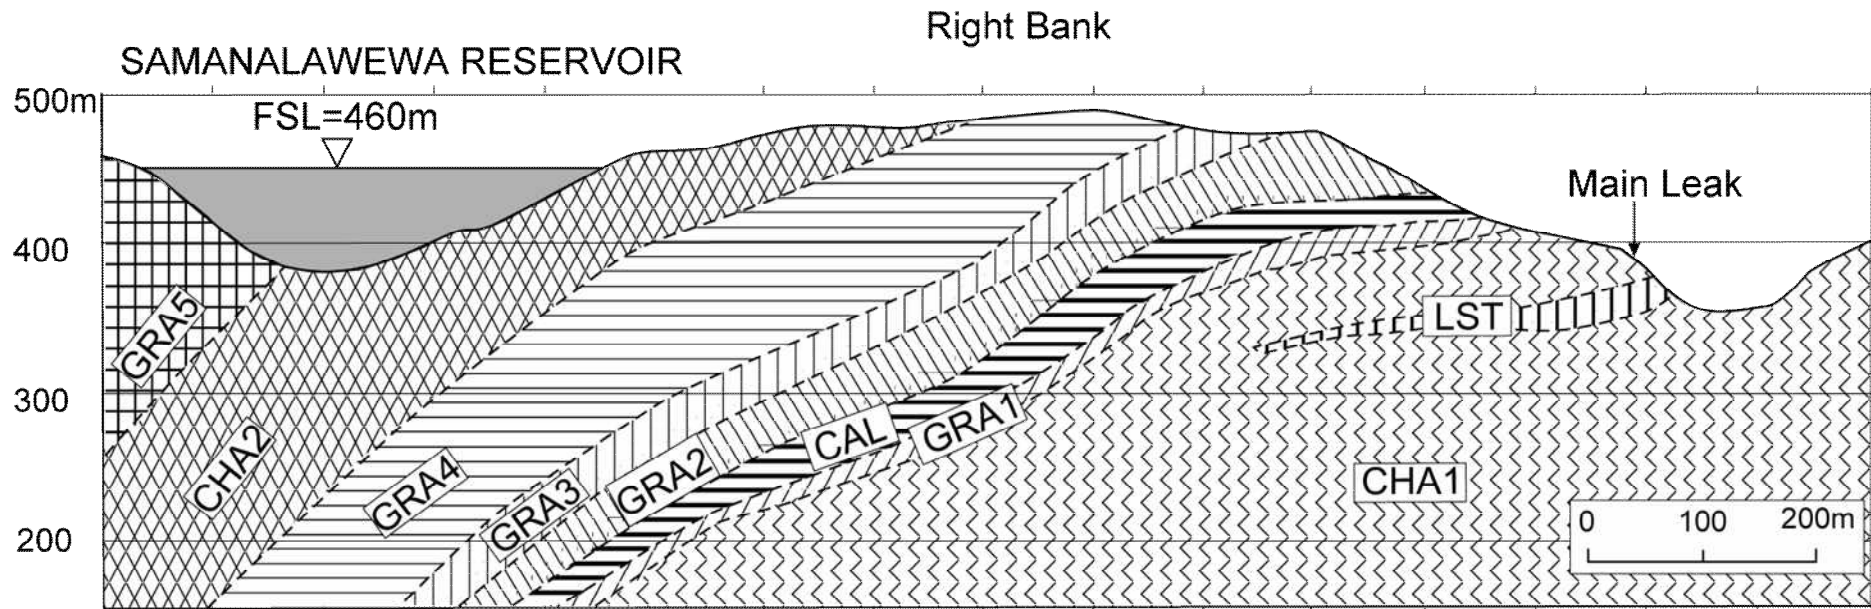
**Figure 3.3** Geological cross section perpendicular to the right bank and across the leakage outlet

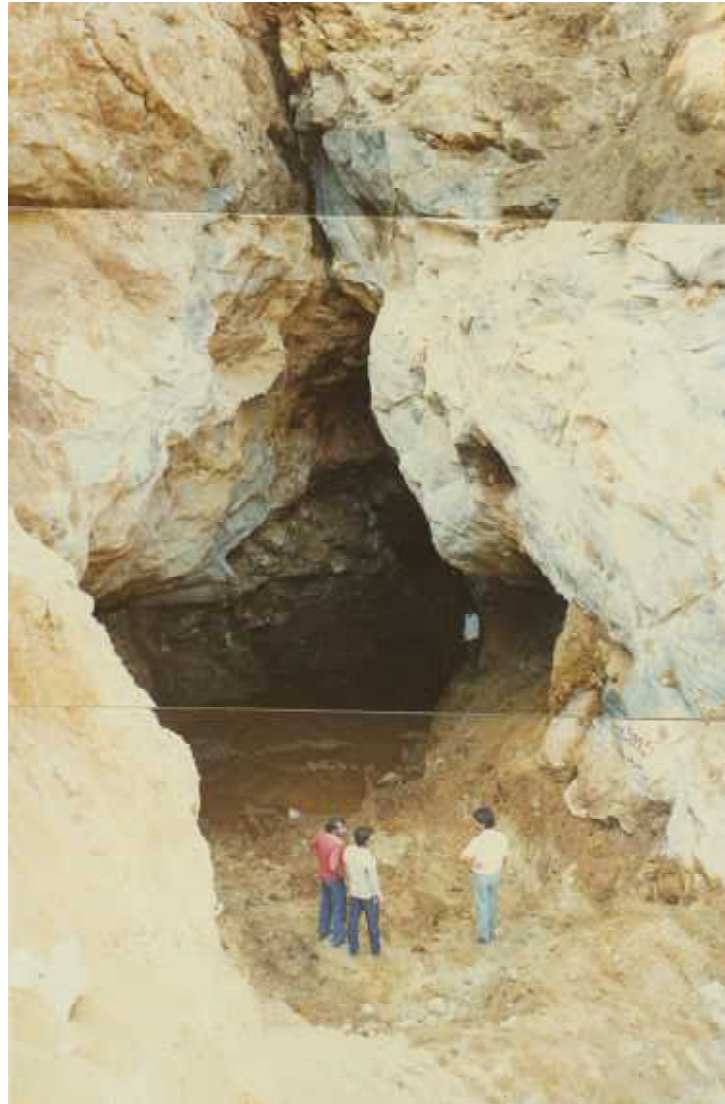
**Figure 3.4** One of the Karstic caves found during excavations, in the right abutment

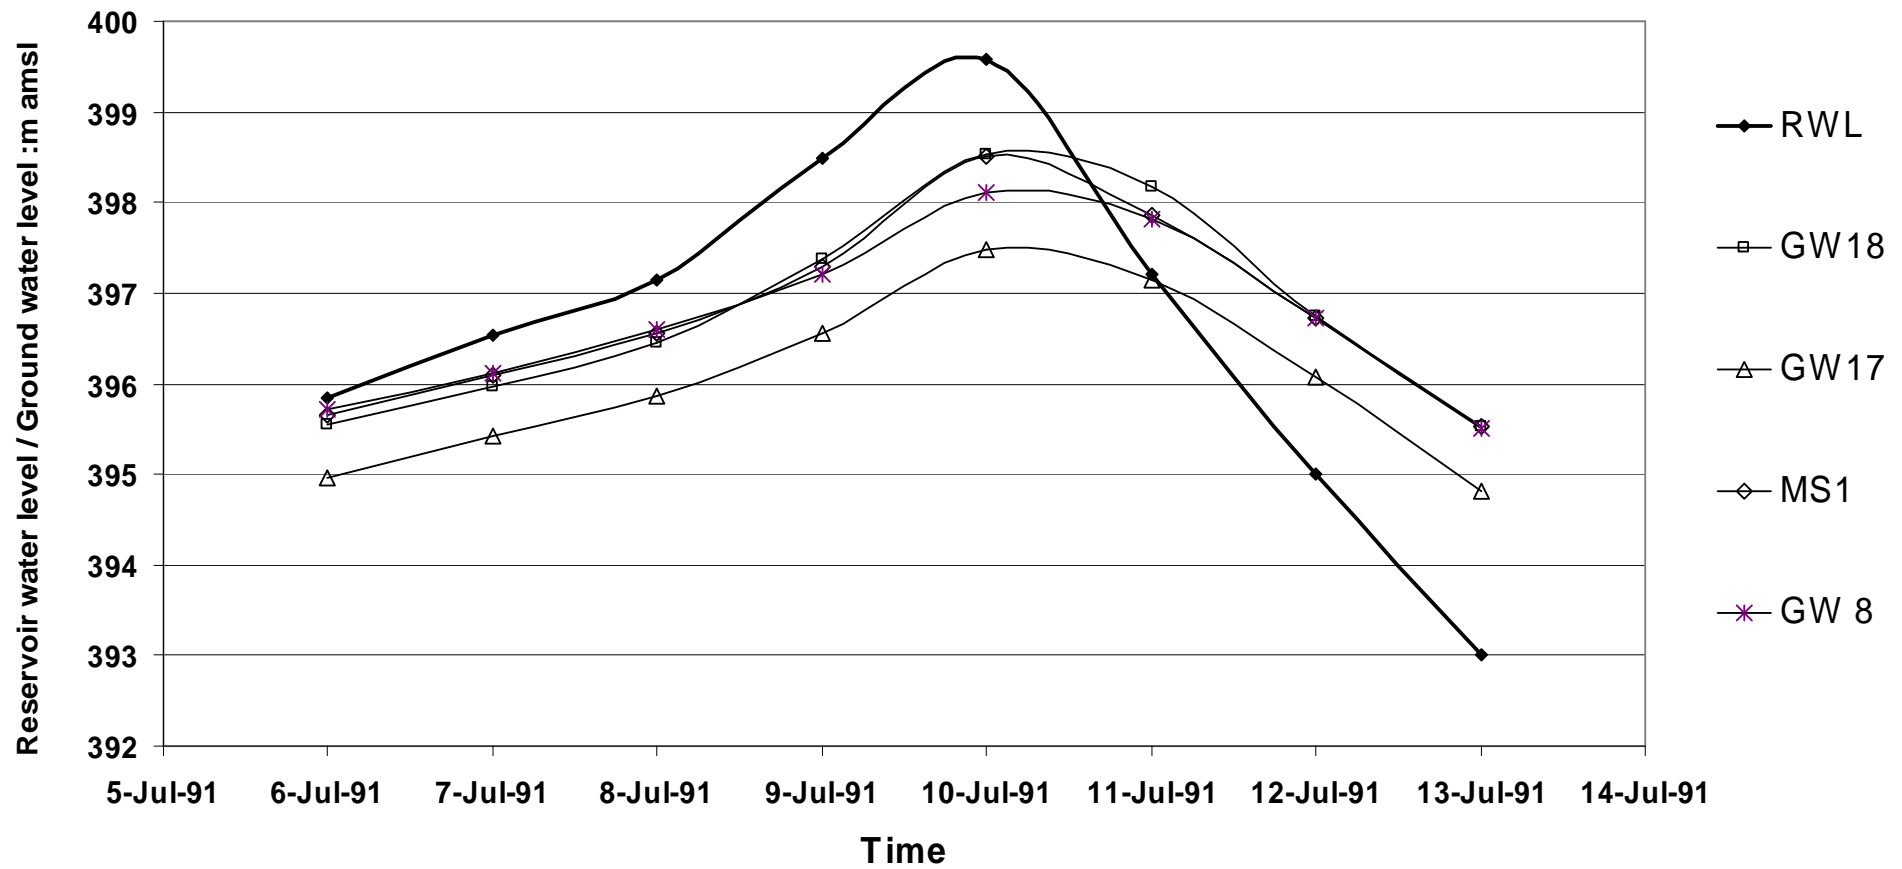
With the impounding, reservoir water level gradually increased. At the same time the ground water level in the right bank too started to rise. This was indicated by the ground water monitoring observation wells and piezometers installed in the right bank. The right bank ground water level response was in such a way that it followed the reservoir level very closely. Thus when there was an increase in reservoir water level, the right bank indicated an equal amount of increase in ground water level within 10-15 hours.

**Figure 4.2** Right bank ground water level behaviour during initial impounding

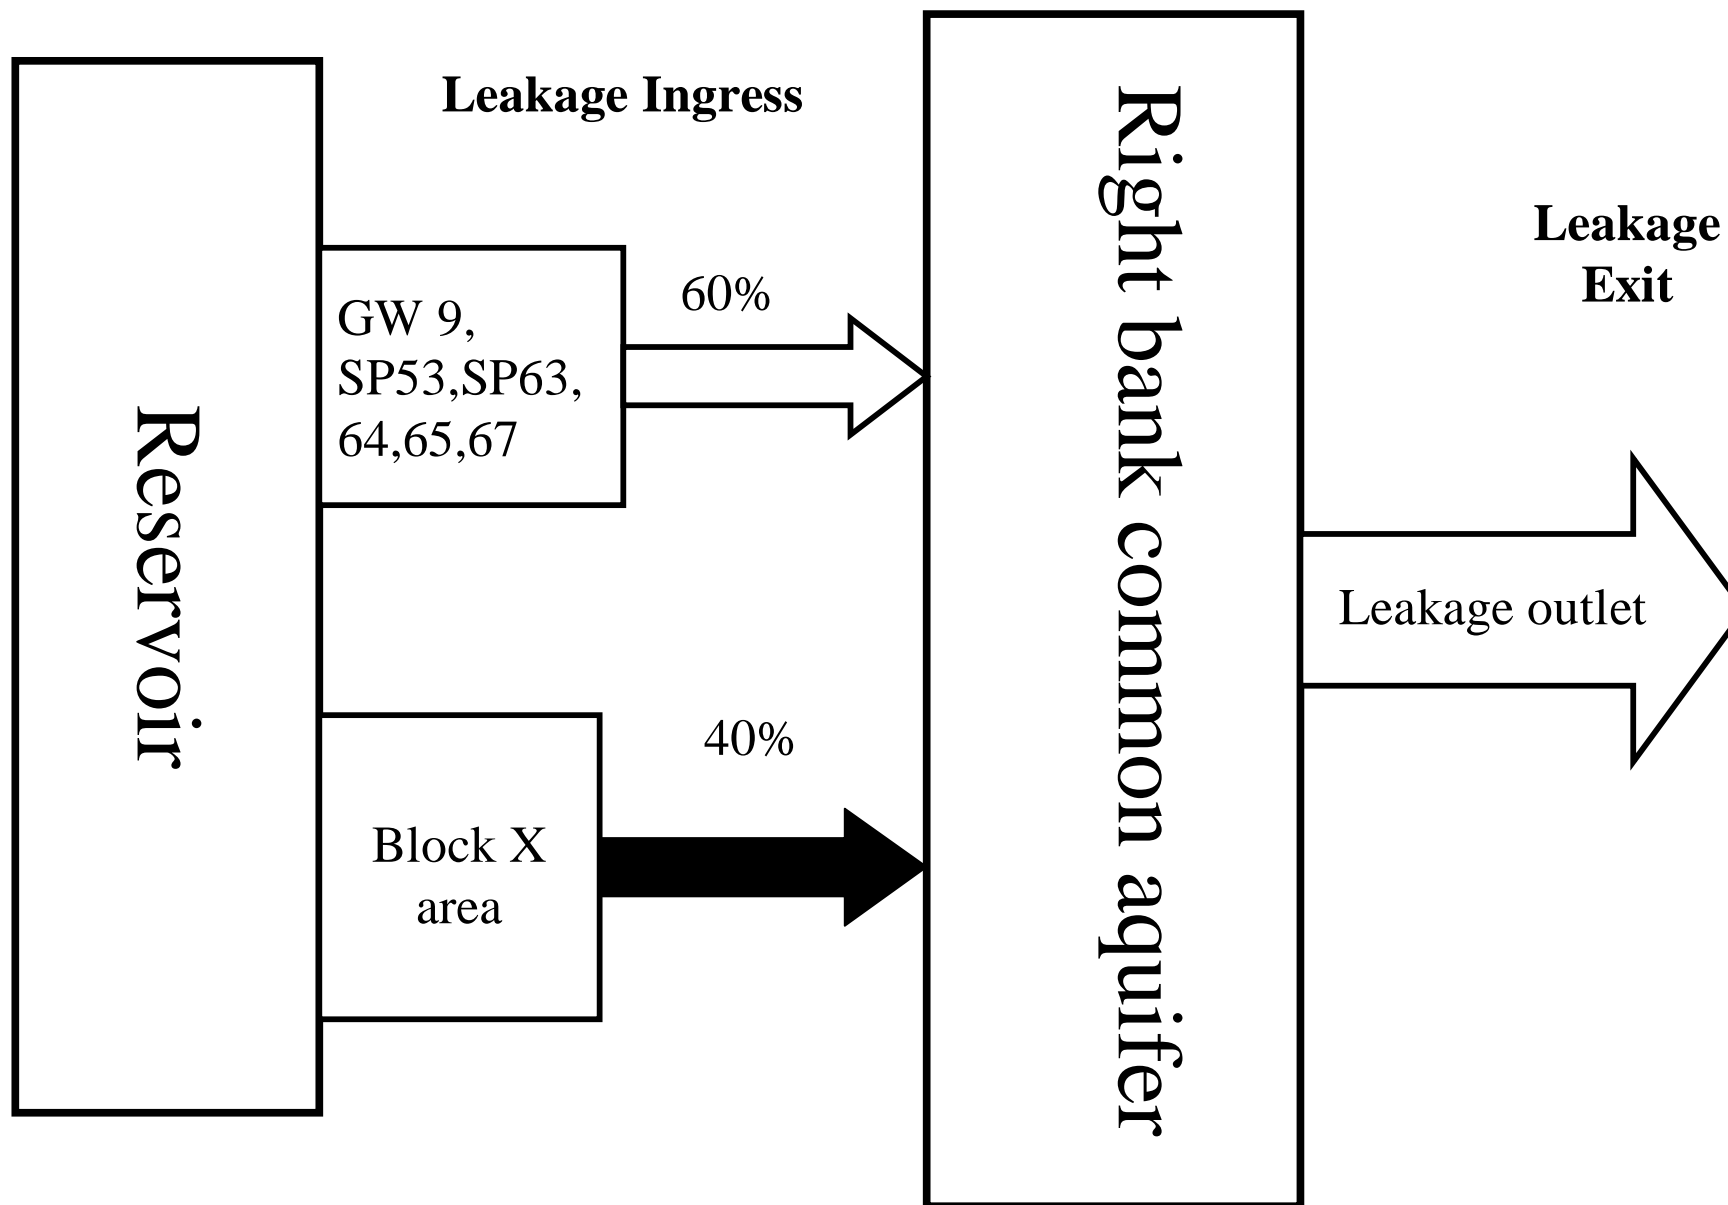
Further with the earth blanket construction, one of the leakage inlets in the block 'X' area, located on the river bed at a location about 500 m up stream of the dam which is accounting to about 40% of leakage ingress contribution got permanently sealed. It also showed that this inlet has been connected to the area in the right bank where GW 6, RBS 16, 17 are installed. Thus based on the above, the reservoir leakage mechanism flow vector diagram can be presented as shown in Figure 6.4.

**Figure 6.4** Leakage Mechanism flow vector diagram
